# Manhole Inspection Summary

Manhole # S31GG\_043MH

Insp Date: 1/23/07 1:35 PM

**Location** Address: **1111 PARK AVE**

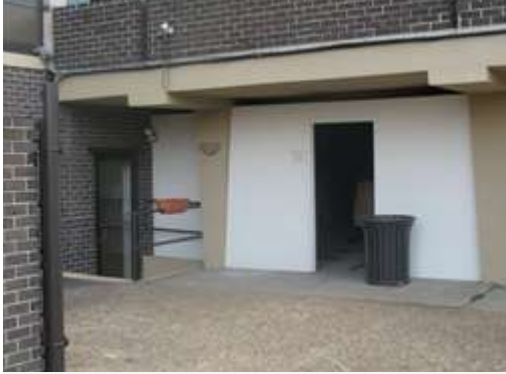
Location View

Comments **MH IS LOCATED INSIDE OF BUILDING.. I3 CONN. COMES FROM BUILDING. MADE CHANGES TO MAP**

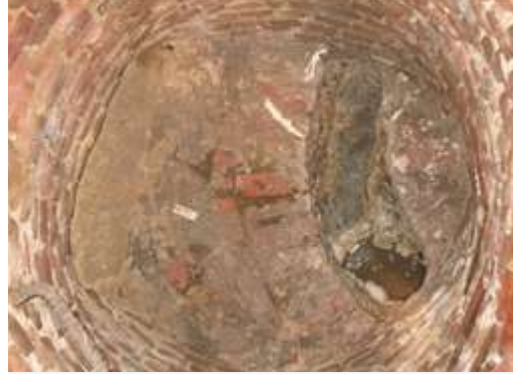
Top View

**Bench** ☒ Exists Material: **Brick** ☐ Parged ☒ **Debris** (not Condition related)

Condition: ☐ Sound ☐ Cracked ☐ Root Intrusion ☐ Deteriorated ☐ Leaks ☒ **Debris**

**Surcharge** ☒ **Evidence Of Surcharge** Depth: **1** (ft.) ☐ Active Surcharge Present

Evidence of surcharge - Bench debris.  
Channel debris.

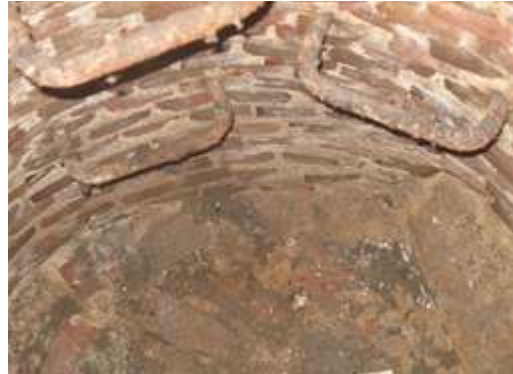
Defect

**Steps** Count: **3** Missing: **0** ☒ **Corroded**

Corroded steps.

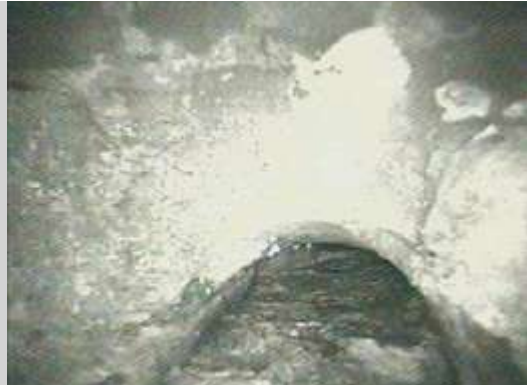
### 8 in. Circular Gravity Sewer Pipe Out @ 12 O'Clock

Deposits: ☐ None ☒ **Mud** ☐ Sludge ☒ **Debris** ☒ **Grease**

Silt Depth: **6** (in.) Deposits Extent: **Heavy**

Infiltration: **Evidence** Pipe Seal Cond: **Unknown**

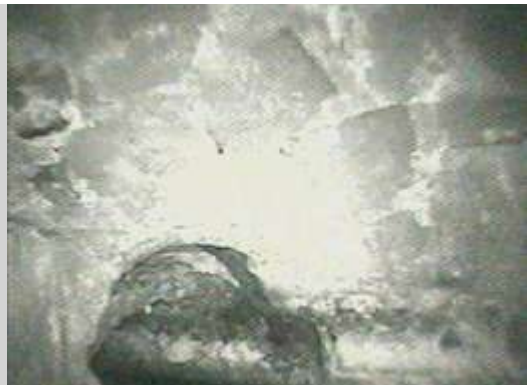
### 8 in. Circular Gravity Sewer Pipe In @ 3 O'Clock

Deposits: ☐ None ☐ Mud ☐ Sludge ☐ Debris ☒ **Grease**

Silt Depth: **0** (in.) Deposits Extent: **Medium**

Infiltration: **Evidence** Pipe Seal Cond: **Broken**
